## Building Inspections

# INSPECTION REPORT

**INSPECTION REPORT FOR:** 21 Jeanette Cres  
SAMPLE NORTH

**REPORT DATE & VERSION:** 28 October, 2015 at 1:04:59 PM  
VERSION 1

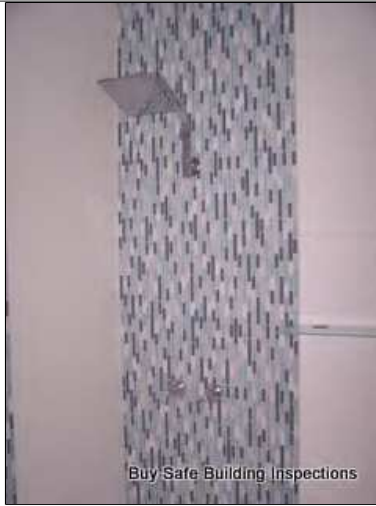
**Bathroom 1**

Leaking + needs reseal + grout seal

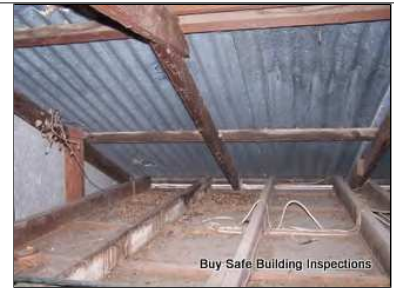
**Construction 1**

No insulation

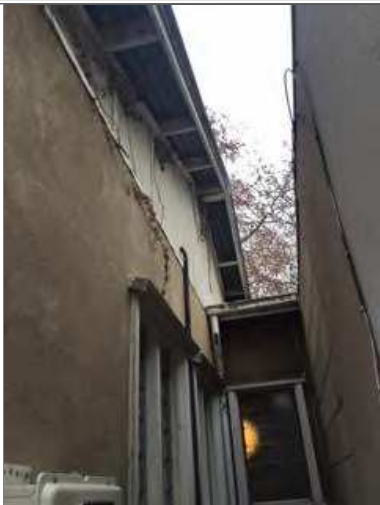
**Construction 1**

Asbestos

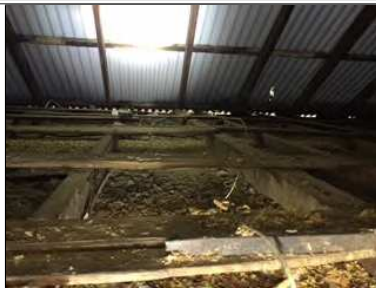
**Construction 1**

Needs attention

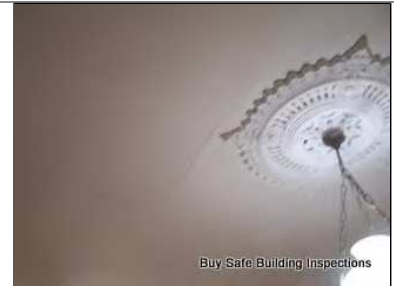
**Lounge 1**

Needs attention

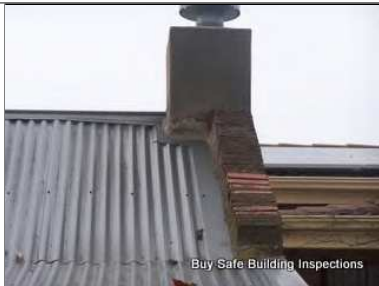
**Outdoors 1**

Needs work

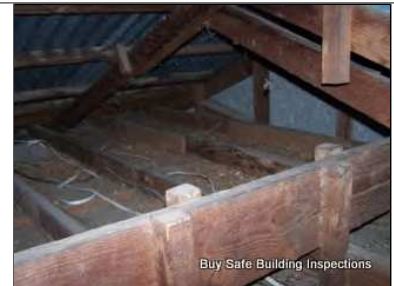
**Outdoors 1**

No insulation

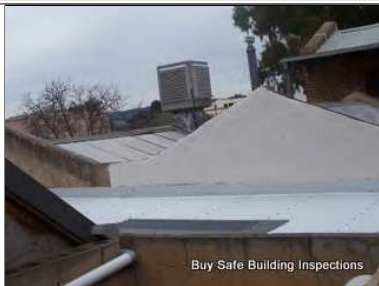
**Outdoors 1**

Needs re-flashing

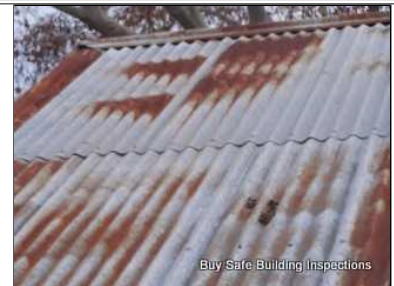
**Outdoors 1**

Rust

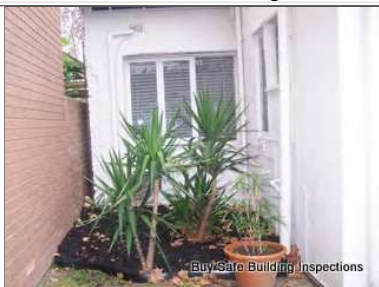
**Outdoors 1**

Needs drainage

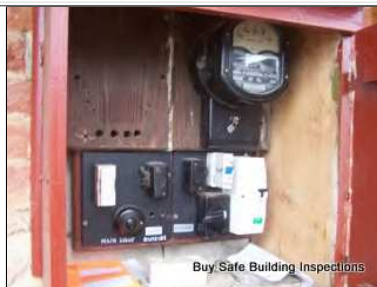
**Services 1**

Needs upgrade

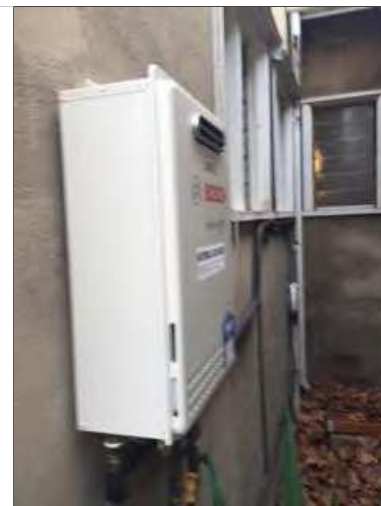
**Services 1**

Gas supply		Satisfactory	
Electric wiring	ATT'N	Unsatisfactory	Needs tidying up Some old wiring Needs checking Old wiring
Downlight Covers	ATT'N	Unsatisfactory	Need to install downlight protective covers
Electric Safety Switch	ATT'N	Satisfactory	Need to install for lights
Smoke detectors	ATT'N	Unsatisfactory	Need to install 2 new hardwired
Hot Water Service	ATT'N	Unsatisfactory	Due for replacement

Due for replacement
